Airborne and spaceborne images for earthquake damage detection of expressways and buildings

Abstract

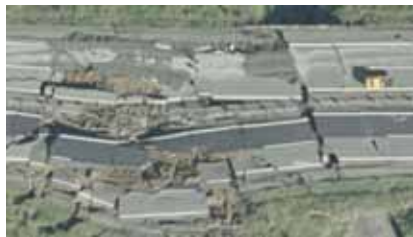
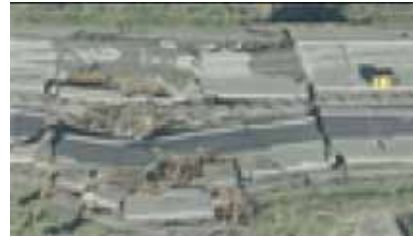
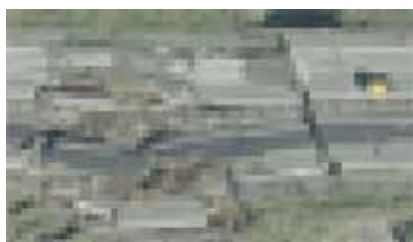
Aerial Photo

QuickBird (60cm)

IKONOS (100cm)

SPOT-5 (250cm)

Fig. 2 Visual damage detection based on images with various resolutions (214.5 kp)

In the Niigata-ken Chuetsu earthquake, which occurred on October 23, 2004, severe and minor damages were found in the expressway network. The expressways had been in the traffic regulation because of the damages caused by this earthquake for about a month. The spatial distribution of JMA (Japan Meteorological Agency) seismic intensity was estimated based on Kriging technique (Fig. 1) to reveal the relationship between the damage of expressways caused by the 2004 Niigataken-Chuetsu earthquake and the seismic intensity. The areas where the expressway suffered from many damages were subjected to severe ground motion whose JMA seismic intensity was larger than 6.0. The major and minor damages of expressways can be detected using aerial photographs. The capability of high-resolution optical satellite images for the purpose of visual damage detection was also evaluated in this study (Fig. 2).

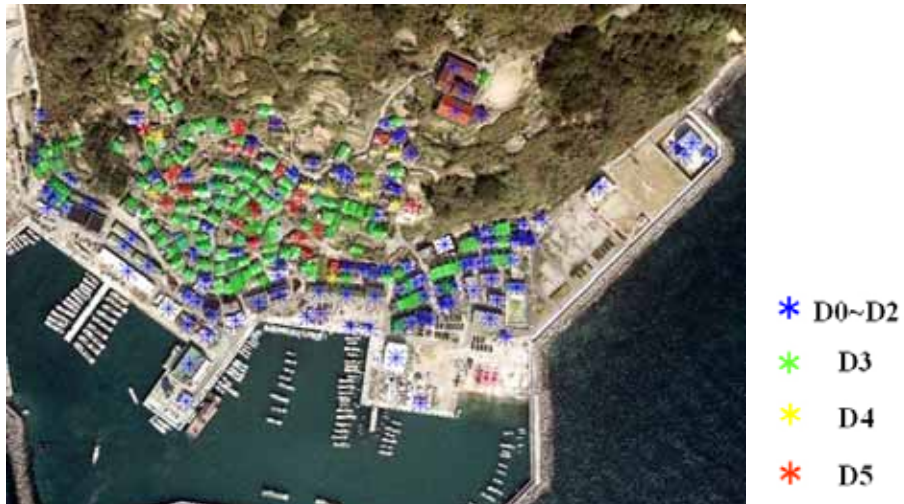
Fig. 3 Result of visual damage inspection of Genkai-jima island using a vertical aerial photograph

On March 20, 2005, the Fukuoka-ken Seiho-Oki earthquake occurred. An island named Genkai-jima island, which is located near the epicenter, suffered from severe damages, and all inhabitants had to evacuate from the island. The field survey to investigate the damage level of each wooden house was conducted by the authors. The visual damage inspection for wooden houses in this island was conducted using a vertical aerial photograph (Fig. 3). The result of visual damage inspection was verified based on field photos and diagonal aerial photographs (Fig. 4), and our photo interpretation seems to give reasonable accuracy.
