Estimation of Damage Ratios of Wooden Houses and Water Distribution Pipelines in an Earthquake Scenario for the Tokyo Metropolitan Region

*Yoshihisa Maruyama¹⁾ and Fumio Yamazaki²⁾

^{1), 2)} *Department of Urban Environment Systems, Chiba University, Chiba, Japan*

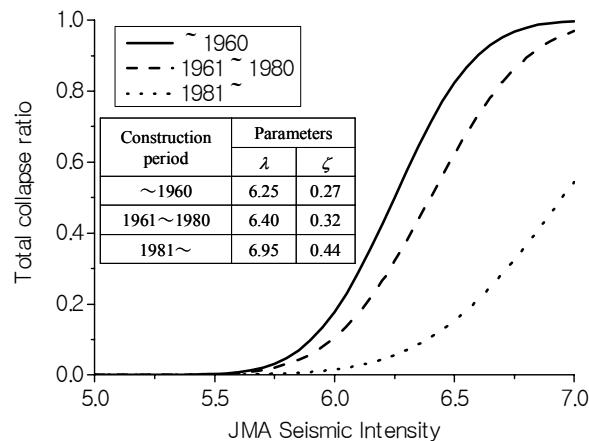
Fig. 4. Total collapse ratios of wooden houses with respect to their construction periods estimated from Eq. (1).

This study considers damage to wooden houses caused by shaking. The effects of fires, liquefaction, landslide, and other sources of building damage are excluded from this study. The damage ratios of wooden houses are estimated from Eq. (1) (Yamaguchi *et al.* 1998). The parameters of Eq. (1), λ and ζ , are defined using the construction period of the buildings. Figure 4 shows the relationship between the total collapse ratios of wooden houses and JMA seismic intensity (I) estimated using Eq. (1).
