PHOTO-INTERPRETATION OF BUILDING DAMAGE DUE TO EARTHQUAKES USING AERIAL PHOTOGRAPHS

Naoki OGAWA¹ and Fumio YAMAZAKI²

SUMMARY

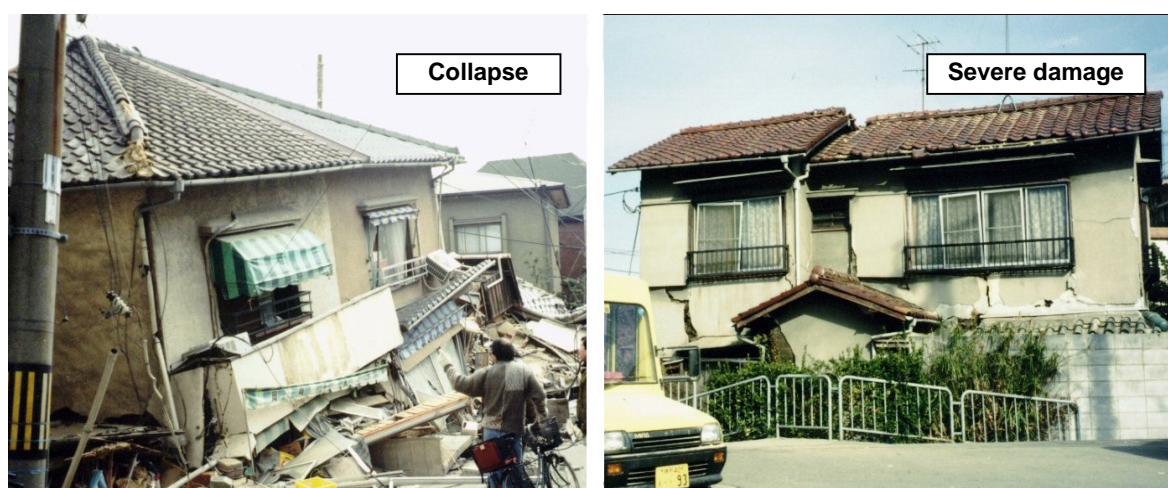
Photo 1: An example of ordinary “severely damaged” buildings and “collapsed” buildings

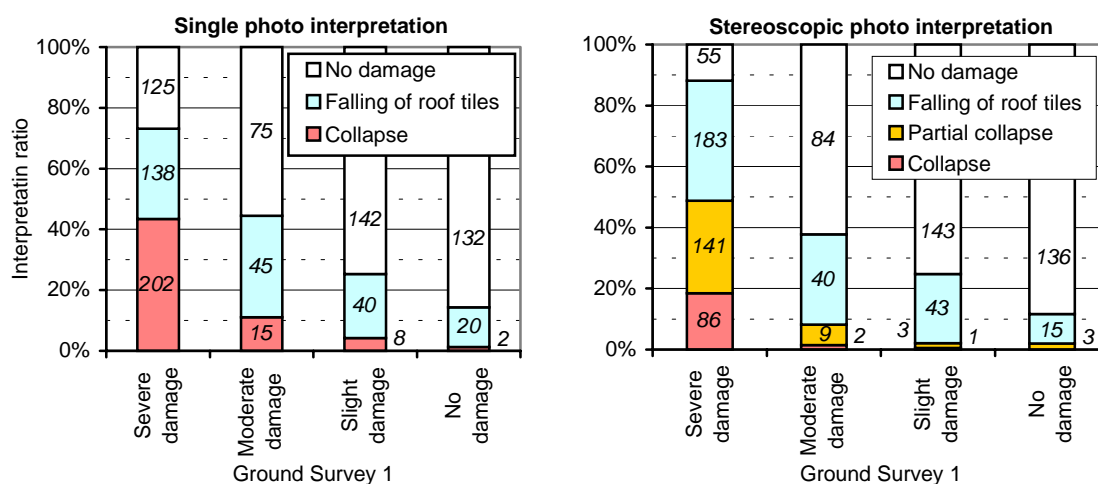
Figure 2: Relationship between the results of Ground Survey 1 and aerial photo-interpretations

Building damage was found in 472 (50%) of 946 buildings by single photo-interpretation. Among these, “collapse” applied to 227 buildings (24%) and “falling of roof tiles” to 244 buildings (26%). Building damage was detected in 528 (56%) of 946 buildings by stereoscopic photo-interpretation. Among these, “collapse” applied to 89 buildings (9%), “partial collapse” to 157 buildings (17%) and “falling of roof tiles” to 281 buildings (29%). The relationship between Ground Survey 1 and the aerial photo-interpretation is shown in Figure 2. Comparing the result of photo-interpretations with that of Ground Survey 1, single photo-interpretation and stereoscopic photo-interpretation showed almost the same tendency.

The percentage of buildings whose damage can be identified from the aerial photographs decreases as the damage level in Ground Survey 1 becomes low. The rate of damage detection for “severe damage” buildings in the ground survey data was comparatively high, 73% in single-photo interpretation and 88% in stereoscopic photo-interpretation. However, all the damage classifications in the photo-interpretation criteria were included in this damage detection. The side-view information for low-rise buildings can not be obtained for most cases from aerial photographs. Therefore, compared with Ground Survey 1, the damage level could not be distinguished into several classes; it was only classified as “collapse” and other visible damage to roofs. The rates of detection of damage smaller than “severe damage” by Ground Survey 1 were not much different between single and stereoscopic photo-interpretations.

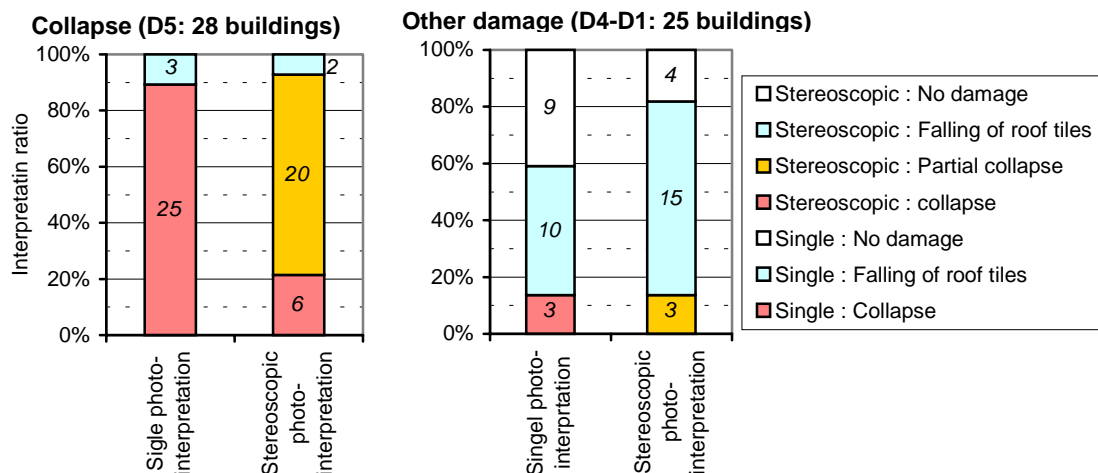
Figure 3: Comparison of the result of ground photo-interpretation, divided into “collapse (D5)” and the other damage levels (D4-D1), with that of aerial photo-interpretation

In order to evaluate the results of aerial photo-interpretation for collapsed buildings, a comparison with the ground photographs was conducted. The relationship between the results of interpretations from ground photographs and aerial photographs is shown in Table 3. The results of the ground photo-interpretation, divided into “collapse (D5)” and the other damage levels (D4-D1), were compared with the results of aerial photo-interpretations, as shown in Figure 3. For “collapse (D5)” by the ground photographs, “collapse” by single photo-interpretation and “collapse” and “partial collapse” by stereoscopic photo-interpretation are almost the same number. The rates of determination of “collapse (D5)” in both single and stereoscopic photo-interpretations are high at about 90%. For other damage levels (D4-D1), although about 10% of damage were mistaken as “collapse” for both single and stereoscopic photo-interpretations, most of the damage was identified as “falling of roof tiles”. In summary, collapsed buildings could be correctly identified but less severely damaged buildings could not by aerial photo-interpretation.

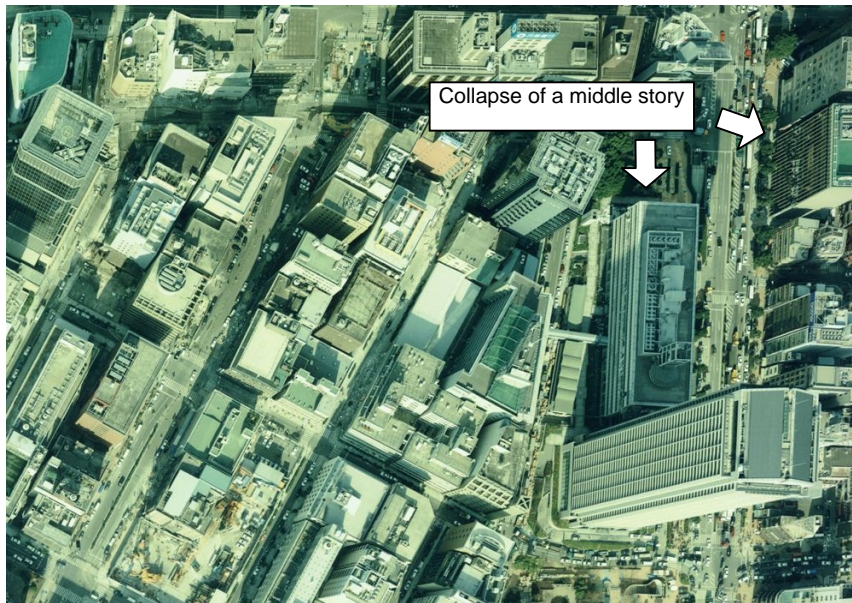
Photo 3: An example of aerial photographs for the non-wooden building area

The ground survey for building damage was conducted by the Kinki branch of the AIJ [AIJ, 1995]. The members of this survey were structural/construction engineers (hereafter referred to as Ground Survey 2), and its damage classification was more detailed than that of Ground Survey 1. The criteria of damage classification in Ground Survey 2 is shown in the companion paper by Hasegawa et al. [2000]. An example of aerial photographs for the non-wooden building area is shown in Photo 3.

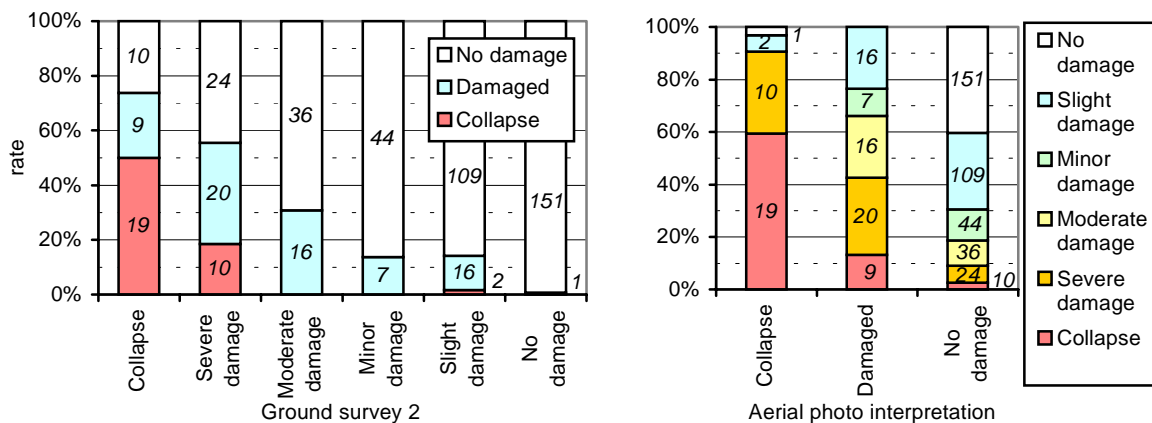
Figure 6: Relationship between the results of Ground Survey 2 and single photo-interpretation

Building damage was found in 100 (21%) out of 474 buildings by single photo-interpretation. Among those, “collapse” applied to 32 buildings (7%) and “damaged” to 68 buildings (14%). The relationship between the results of Ground Survey 2 and the aerial photo-interpretation is shown in Figure 6. In Ground Survey 2, although the rate of damage detection for “collapse” was comparatively highly as 74%, “severe damage” was 56% and damage classifications smaller than these were 40% or less. Most of “collapse” buildings interpreted from the aerial photographs were “collapse” and “severe damage” in Ground Survey 2. Those ratios of correct interpretation were low compared with those for “collapse” buildings in the wooden building area. Damage patterns differ significantly between non-wooden buildings and wooden buildings. For non-wooden buildings, complete collapse as seen in wooden buildings is rare while the collapse of a middle story and destruction of the lowest story are often observed for non-wooden buildings. In damage determination of non-wooden buildings, the side views of the buildings were important. Thus aerial photographs of a scale larger than that used for the damage interpretation of the wooden building area was used. However, information on the sides of buildings may not be obtained, depending on the position of buildings in photographs, the density of buildings, and the height of buildings. Hence, the rate of determination of damage was lower than that for wooden buildings.
