# Automated Detection of Damaged Buildings using Aerial HDTV Images

Hirotsada Hasegawa, Hisashi Aoki, Fumio Yamazaki, Masashi Matsuoka

Earthquake Disaster Mitigation Research Center, RIKEN

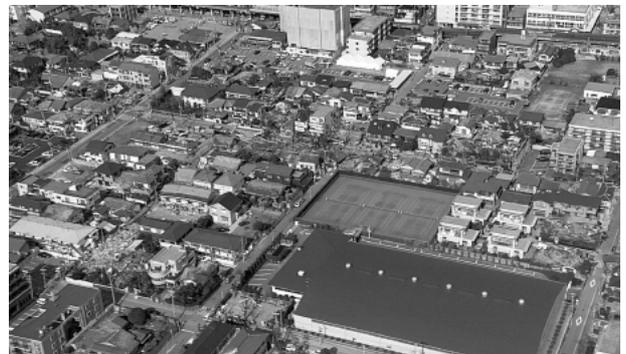
Fig. 1 Aerial HDTV image used in this study

Aerial shootings from helicopters for the area affected by the Kobe earthquake started shortly after the event by the Japan Broadcasting Corporation (NHK). These images were taken at a 30-45 degree angle from the vertical direction, from a height of about 300m by NHK's HDTV cameras. In this study, we used some of these images taken 10 days after the event. The HDTV images were converted to RGB image data prior to use. One of the images used in this study is shown in Fig. 1. The spatial resolution of this image is approximately 9cm and 17cm for near and far distances from the camera, respectively. The area covered in this study includes several blocks (about 200m x 230m = 46000m<sup>2</sup>) in Nishinomiya City [4]. In this area, many wooden buildings suffered severe damage due to the earthquake.
