Detection of Slope Failures due to the Iwate-Miyagi, Japan Earthquake using Satellite Images

F. Yamazaki & T. Ishide

Department of Urban Environment Systems, Chiba University, Japan.

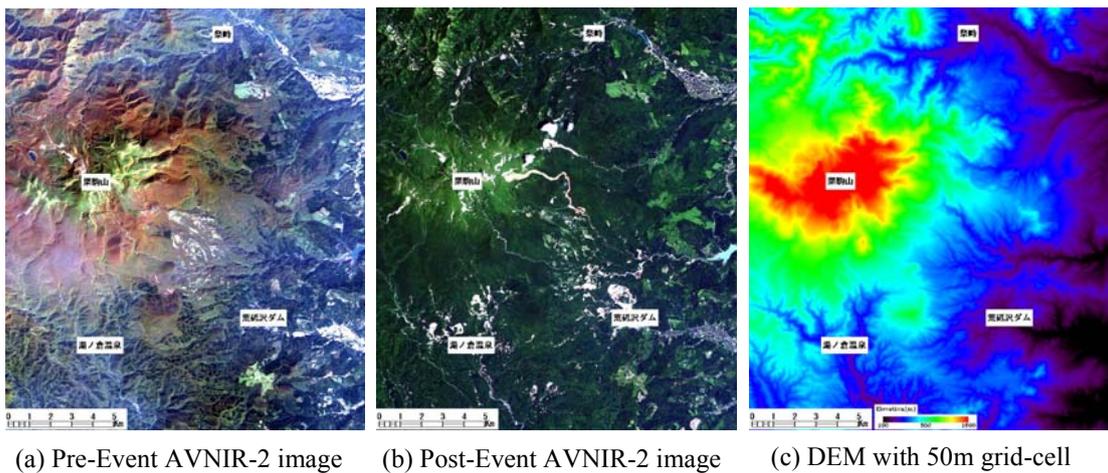
Figure 1. The pre-event and post-event ALOS/AVNIR-2 images and the DEM with 50 m grid-cell

Soon after the occurrence of the event, aerial damage surveys were conducted by Geographical Survey Institute (GSI) and private aerial survey companies. Since the affected region was vast and difficult to reach, various satellite sensors also tried to capture images. ALOS captured the affected areas both before and after the earthquake by its AVNIR-2 and PALSAR sensors. Figure 1 shows a part of ALOS/AVNIR-2 images taken (a) before and (b) after the earthquake, and the digital elevation model (DEM) of the study area with 50m grid-cell. The pre-event image was taken on October 17, 2006 at 10:53 am (JST) from the path No. 79 with the pointing angle 34.3° while the post-event image was taken on July 2, 2008 at 10:25 am (JST) from the path No. 67 with the pointing angle -2.5°. The AVNIR-2 images have four multi-spectral bands (B, G, R, NIR) with spatial resolution of 10 m. The co-registration of the two images and the DEM was carried out before image analyses.

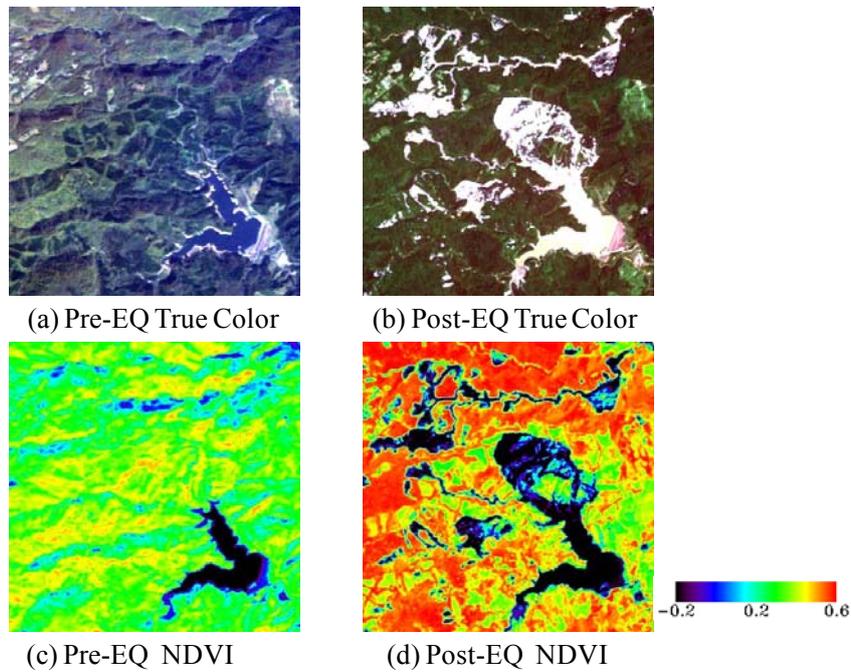
Figure 2. True color composite and NDVI images of Aratozawa Dam area

Figure 2 shows the NDVI values of the part of images near Aratozawa Dam, where the largest landslide occurred in the upstream of the dam. Comparing the NDVI values of the pre- and post-event images, the post-event NDVI value is seen to be much higher because the post-event image was taken in the early July (when the vegetation is most active in this region) while the pre-event image was taken in the mid October (when autumn foliage starts in highland).

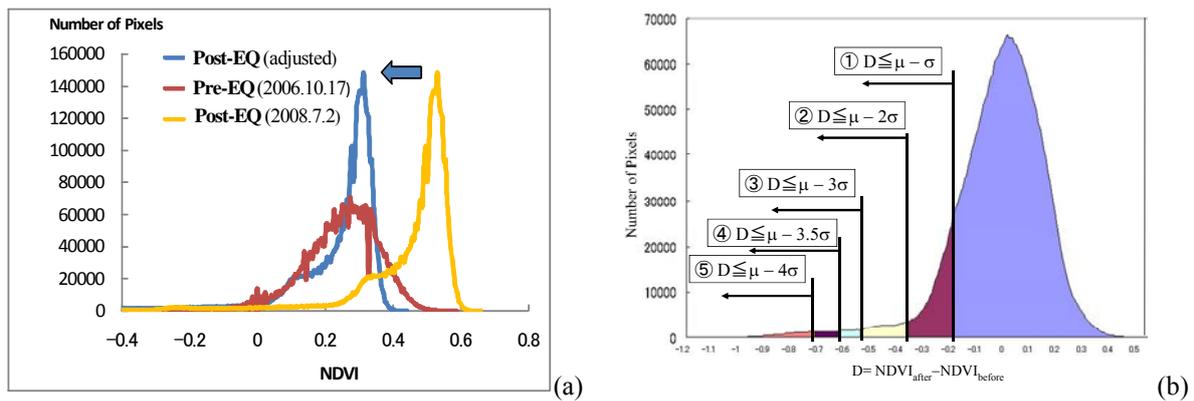
Figure 3. (a) The histograms of the pre- and post-event NDVIs and the adjusted post-event NDVI and (b) the histogram of the NDVI difference D after the adjustment

Figure 3 (a) plots the histograms of the NDVI value for the vegetated areas of the pre- and post-event images. Since the NDVI is higher in the post-event image, the post-event NDVI value was reduced (-0.217) so that the mean NDVI values of the two images in the vegetated area become equal. After this adjustment, the mean NDVI values became almost equal for the two images although the standard deviations are still different.

The difference (D) of the adjusted post-event and the pre-event NDVI values was calculated for each pixel and the histogram of the D value is shown in Figure 3 (b). The difference of the NDVI in time is considered to be caused by several factors, e.g. slope failure and landslide, the remaining seasonal change after the adjustment, the difference of sensor's view-angle. The distribution of the difference is seen to be non-symmetric with a long tail to the negative direction, which is consistent with the decrease of the NDVI due to slope failure/landslide. It is not easy to determine the threshold value to extract the change to bare-ground with other random variation. Thus following the previous studies (Yusuf et al. 2001; Miura and Midorikawa, 2008), the effect of the threshold value was examined by superposing the extracted pixels by different thresholds on the post-event image. The five threshold values shown in Figure 3 (b) were used to extract the earthquake-induced change and the results are plotted in Figure 4. Visual inspection of Figure 4 suggests that the area by $D \leq \mu - 2\sigma$ overestimates the

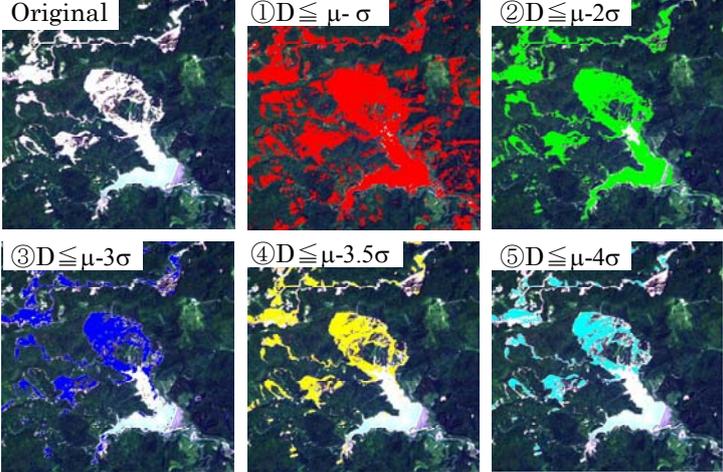
Figure 4. Extracted bare ground corresponding to the different threshold values of the difference of NDVIs

change while the area by $D \leq \mu - 3.5\sigma$ underestimates it. And hence, the area determined by $D \leq \mu - 3\sigma$ was considered as the earthquake-induced ground failures. Figure 5 (a) shows the extracted earthquake-induced change (62,422 pixels) for the entire study area by this method. The extracted area changes with the threshold value used, and thus the threshold value should be determined examining the balance of omission and commission errors (or the producer and user accuracy).

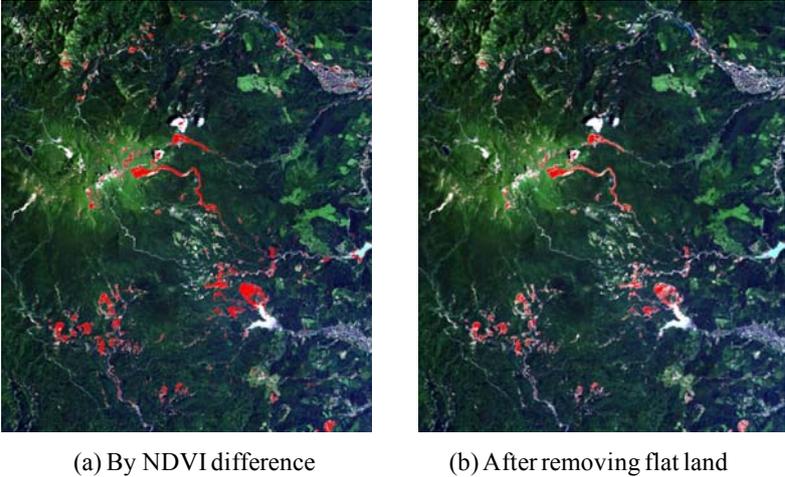
Figure 5. Extracted bare ground for the whole study area by the difference of NDVIs

Figures 5 (b) and 7(b) show the extracted results after removing the pixels with less than 10 degree. By this treatment, the total numbers of pixels extracted as slope failures were reduced to 52,313 for the NDVI method and 47,765 for the classification method. Figure 10 plots the result after removing the flat area for Figure 8. It is seen that the miss extractions in the farm have been eliminated correctly but that the errors in the water body still remain. This is due to the reason that the current DEM models the lake bed configuration as the ground surface, and hence the water body could not be removed.

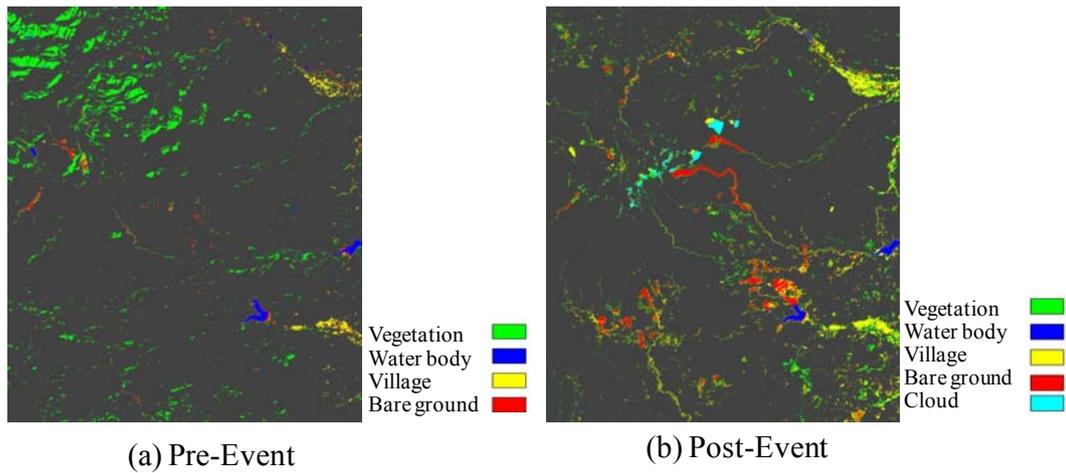
Figure 6. Land-cover classification for non-vegetated areas by the maximum likelihood method

The results of supervised classification using the four multi-spectral bands are shown in Figure 6. As the bare ground class, 10,710 pixels were extracted for the pre-event image and 60,274 pixels for the post-event image. Out of these, 3,582 pixels were identified as bare ground both in the pre- and post-event times. Thus subtracting them from the post-event bare ground pixels, a total 56,692 pixels shown in Figure 7 (a) are estimated to belong to the earthquake induced slope failure/landslide.

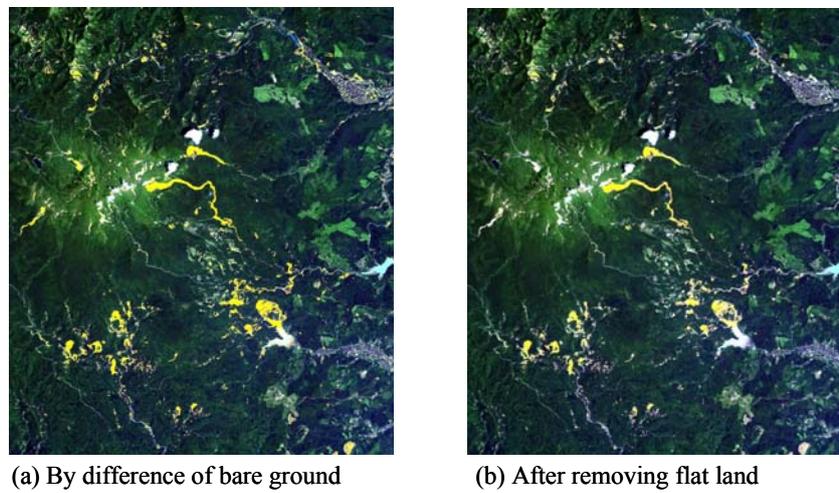
Figure 7. Extracted slope failures/landslides for the whole study area by land-cover classification

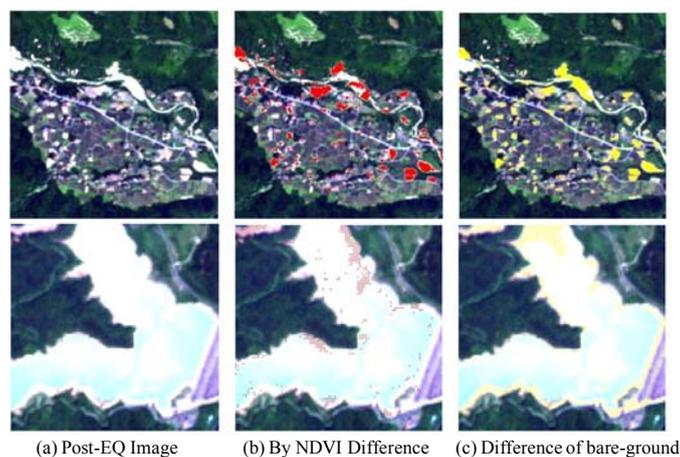
Figure 8. Examples of miss-extraction areas for a flat land (top) and a water body (bottom)

Comparing with the result of visual inspection, the extracted slope failures by the two methods are seen to be reasonable. However, some miss extracted pixels are observed in a flat land (village) and in a water body, as shown in Figure 8. These errors might be caused by the changes of crop in farms, the change of the water level and color, etc. The digital elevation model (DEM) with 50 m grid-cell was employed to remove flat lands from the extracted results.

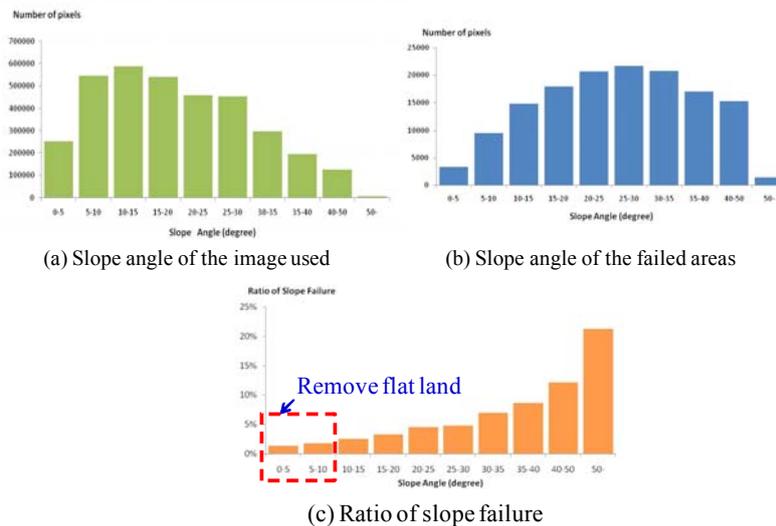
Figure 9. Histograms of the slope angle and the ratio of slope failure

Using the DEM, the slope angle at the position of each pixel was calculated. Comparing the slope angle and the disaster situation map made from aerial photos (Geographical Survey Institute, 2008), the relationship between the slope angle and ground failure was investigated. Figure 9 shows the histograms of the slope angle for all the pixels, for the failed pixels, and the ratio of them. It is seen that the slope failure/landslide occurred mostly for the sloping ground between 30 to 60 degrees, and that the failure ratio increases as the slope angle increases. The similar trend have been observed in the Ikonos image of the 2004 Mid-Niigata, Japan, earthquake (Miura and Midorikawa, 2008) and the QuickBird image of the Sichuan, China, earthquake (Liu and Yamazaki, 2008). The detailed examination for the slope failures/landslides showed that they occurred for sloping grounds steeper than 10 degree. The previous studies (e.g. Miura and Midorikawa, 2008) also support this observation. Thus in this study, the flat lands with less than 10 degree were excluded to reduce commission errors.

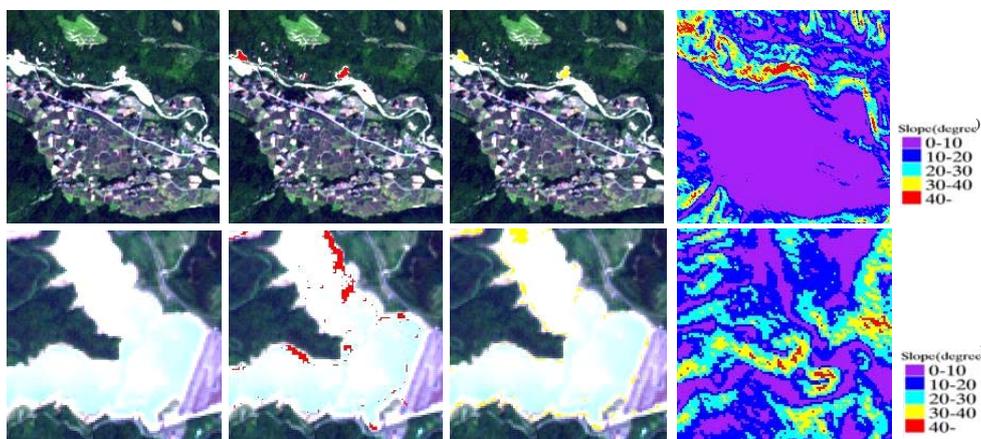
Figure 10. Removal of extracted areas less than 10 degree for flat land (up) and water body (down)

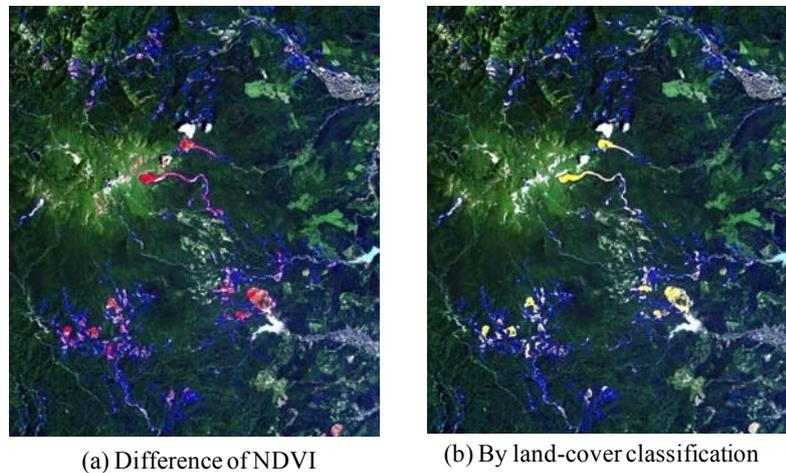
Figure 11. Comparison of the extracted slope failures after removing flat land and the visual inspection result (blue line)

The results of the extraction after removing the low slope-angle pixels are shown in Figure 11, where the visual inspection result based on the aerial photographs (Geographical Survey Institute, 2008) is also plotted in blue lines. Since it is difficult to see details in Figure 11, the enlarged images are shown in Figure 12 for a heavily affected area: around Aratozawa Dam. It is seen that the bare grounds caused by slope failures and landslides well match with the automated extraction results.

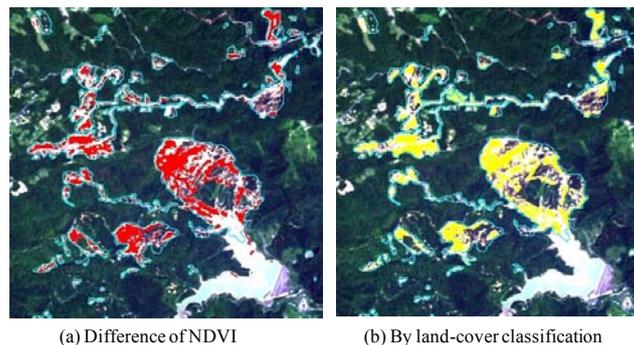
Figure 12. Comparison of the extracted slope failures after removing flat land and the visual inspection result (blue line) around Aratozawa Dam
